Borates HSEQ Initial Alert

Incident:	Contractor entering Dome 2 without proper lock out		
Preliminary Classification:	Observed hazard with key learnings		
Critical Control:	Isolation and Lockout		
Operation / Project:	Boron (RTB)	Location:	Dome 2
Date:	18/02/2019	Time:	2:30 pm
Contact:	Wayne Uhl wayne.uhl@riotinto.com and Ernie Garcia ernie.garcia@riotinto.com

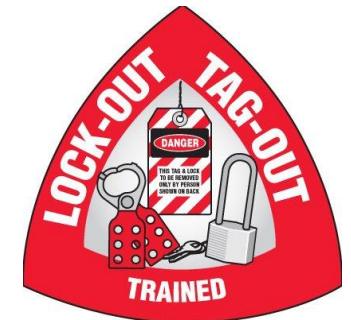
Contractor employee was scheduled to inspect crane hoist. The dome was locked out with partial lock out allowing Rio Tinto employee to perform product pushing to the feeder in middle of the dome. Same lock out was used to perform the crane hoist inspection, no one realized at that time that this partial lock out was not appropriate for this new task. Only 3 days later it was noticed that the lock out was a partial lockout.

- Environment: at no time the filling belt or feeding screw was activated (no imminent danger)
- Equipment: 2 contractor employees were using a man lift to perform the work. The dome filling belt is equipped with an interlock that was working.
- People: The Dome operator was aware of contractor work going on in Dome 2. The lock out procedure was followed, signed by operator, verified and signed by supervisor, none of them realising it was the partial lock out instead of the full lock out. All maintenance work in the Domes need to be done with complete lock out.

- Environment: none
- Equipment: none
- People: The partial lock out was uncomplete (missing the filling belt and 2 side feeders). New isolation procedure was implemented without proper verification leading to required items being overlooked.
