# Borates HSEQ Initial Alert

Incident Number: 1000509398

<b>Incident:</b>	Forklift collided against a post		
<b>Preliminary Classification:</b>	Medical Treatment Injury (MTCI)		
<b>Critical Control:</b>	Road Design and Maintenance		
<b>Operation / Project:</b>	Nules (Spain)	<b>Location:</b>	Street between loading yard and silos
<b>Date:</b>	8/01/2019	<b>Time:</b>	11:00 am
<b>Contact:</b>	Manuel Bonet – Operations manager - +34 964 659205

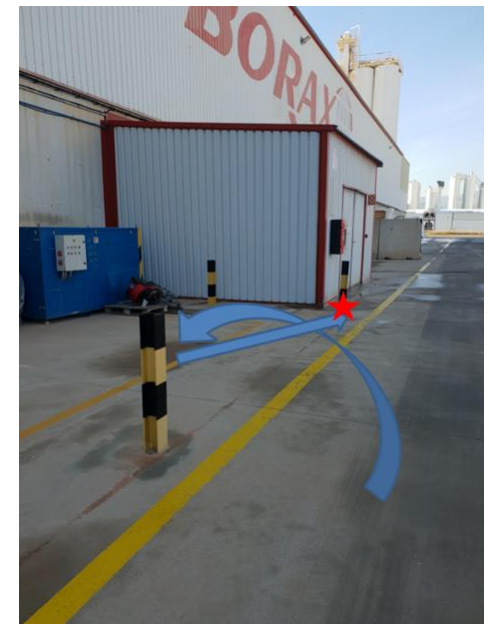
An operator was driving a forklift from the loading yard when a second operator indicated to the first operator to follow him to the silos. To do so, the first operator moved backward to an empty area on the side, waited until the second operator passed and move forward to follow. After driving about 2 meters, the first operator hit a post with his forklift. The first operator was wearing a seat belt, but the sudden hit made his head move forward and his chin hit against the handle of the driving wheel and was cut.

- Environment: Forklift moved into area where post was a hazard. Purpose of post is unclear
- Equipment: Forklift has blind spots by design
- People: The operator has been working on site for about 2 months

- Environment: none
- Equipment: Blind spots are to be considered when driving forklift
- People: People need to have a good understanding of the surrounding area
